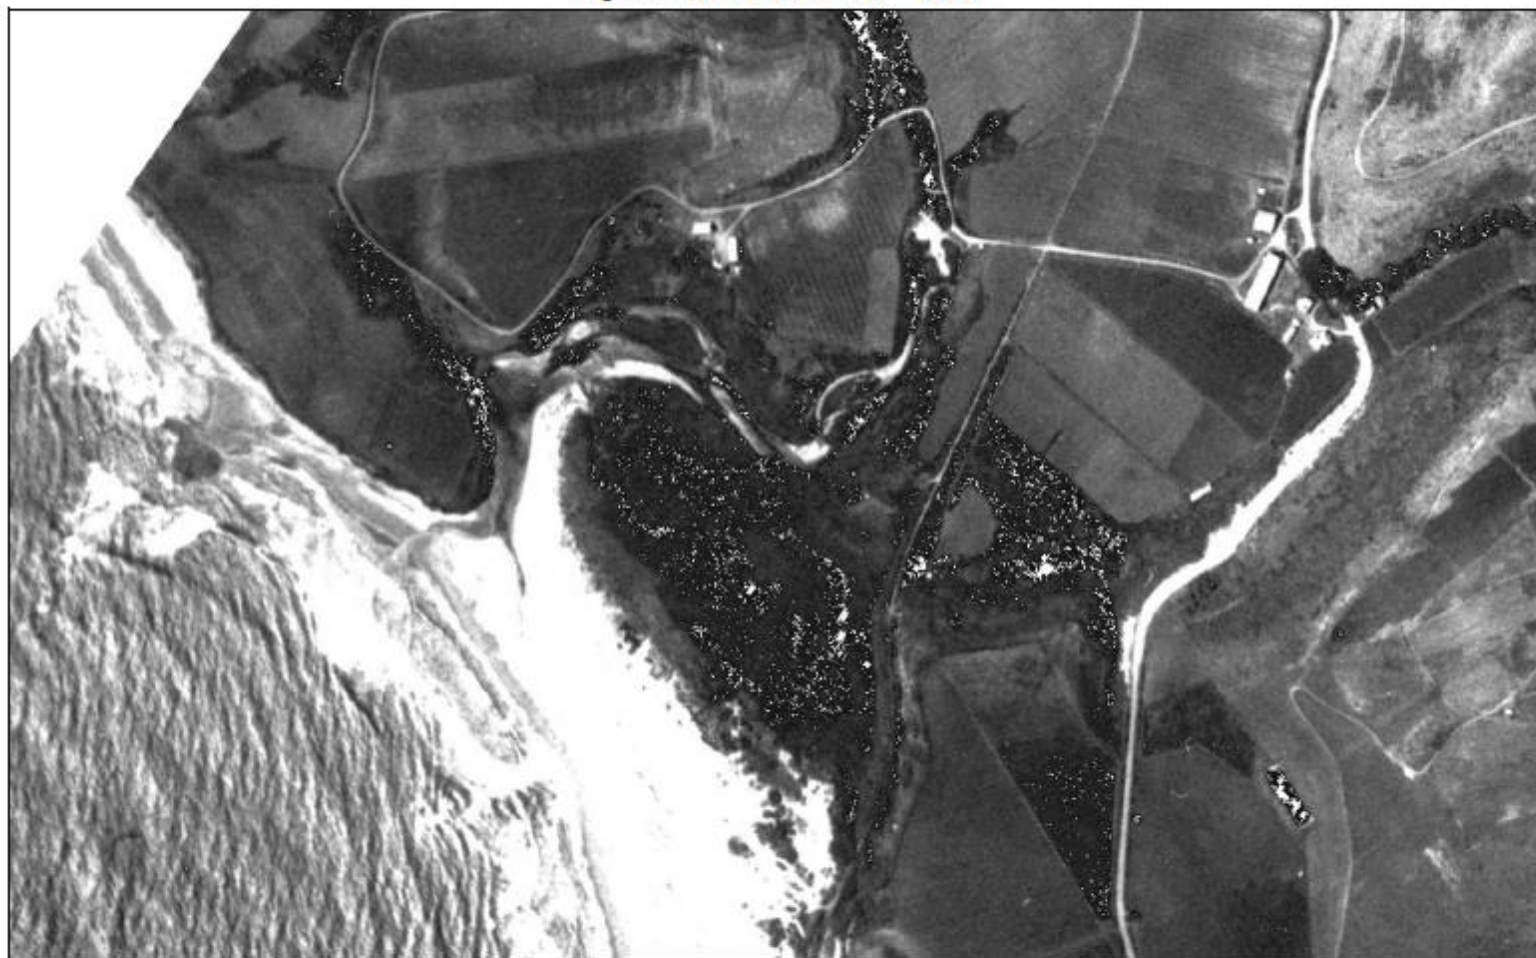
Figure 5-4. Scott Creek – 1928

Aerial photograph of Scott Creek in 1928. Source: University of California—Santa Cruz.

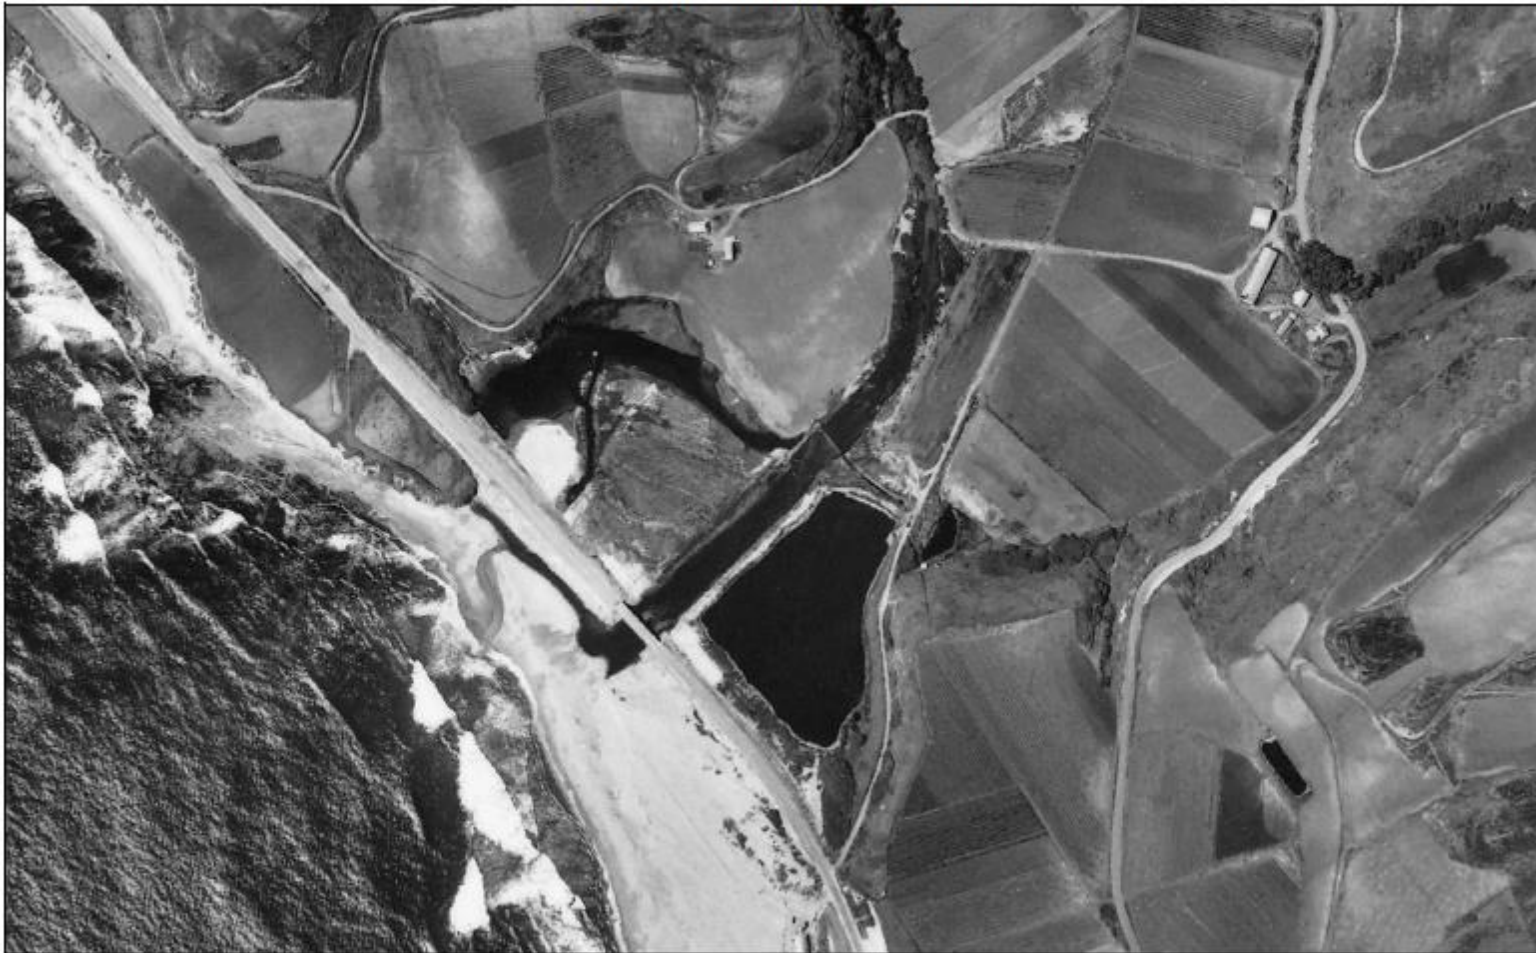
Figure 5-5. Scott Creek – 1940

Aerial photograph of Scott Creek in 1940. Source: California Polytechnic University, San Luis Obispo.

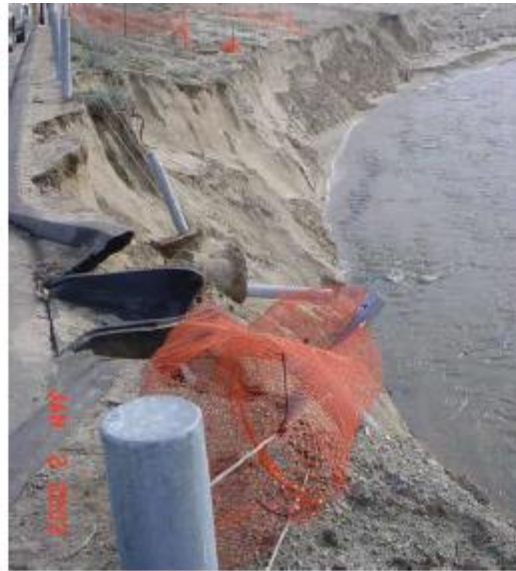
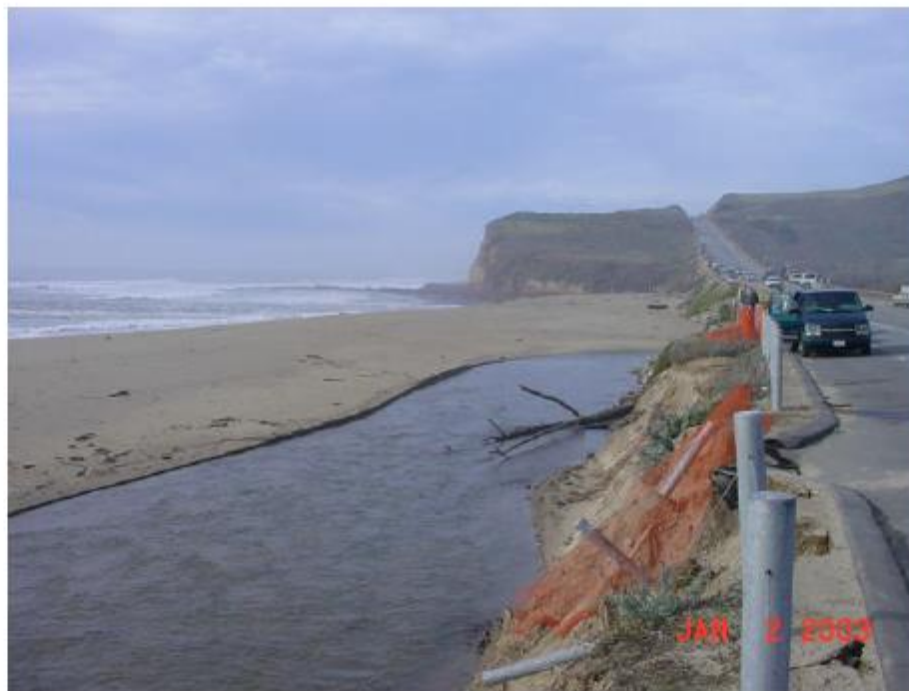
Photographs of dune toe erosion in 2002 when Scott Creek blew out to the south. Because the creek threatened to undermine the roadway, Caltrans placed an emergency revetment (RSP) along the south approach permitted by the California Coastal Commission (e-permit #3-03-006-G).

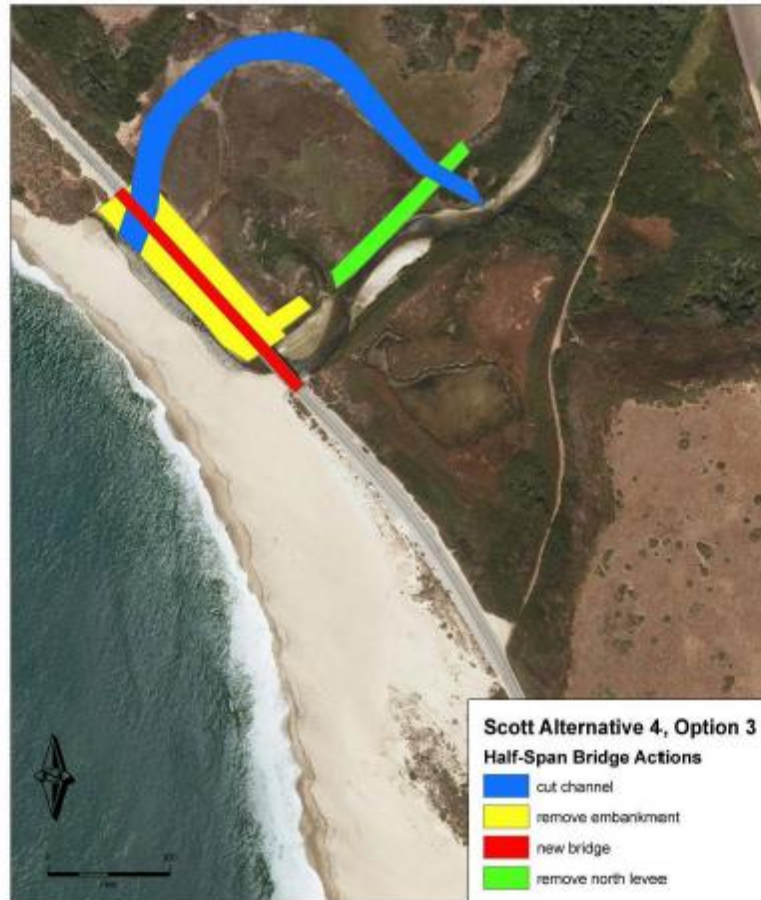
Figure 5-22. Scott Creek Future Conditions—Alternative 4, Option 3

Recommended actions for Alternative 4, Option 3—half-span bridge.
